2019
BIOLOGY
ANNUAL REPORT

Central Arizona Water Conservation District
Water Transmission
by Scott Bryan, Senior Biologist

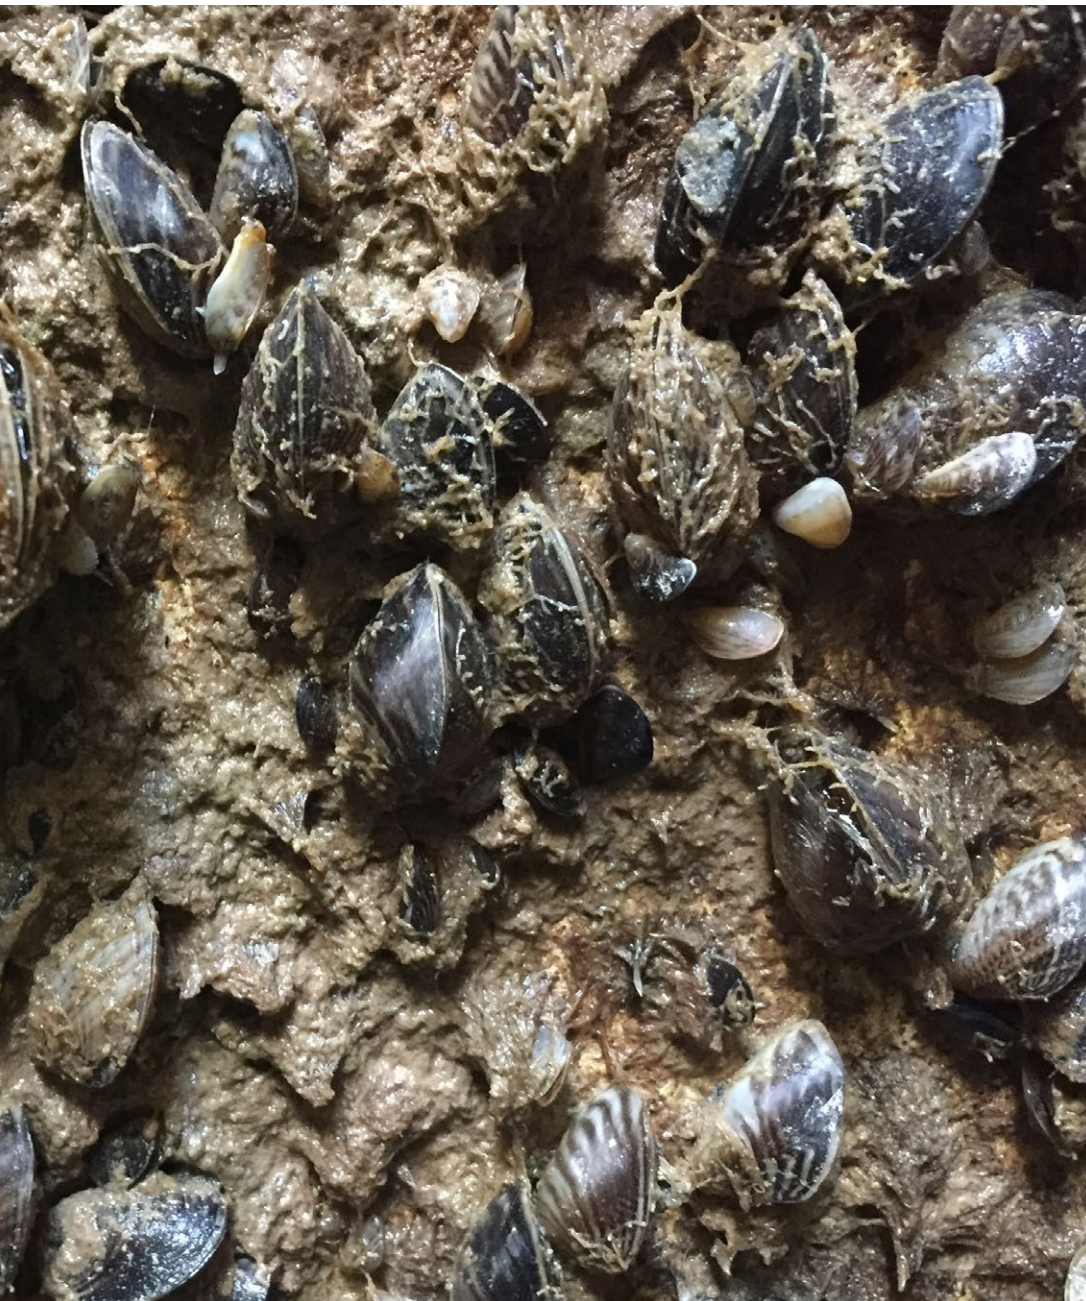
QUAGGA MUSSELS IN GLENDALE TURNOUT
Photo by Jim Geisbush

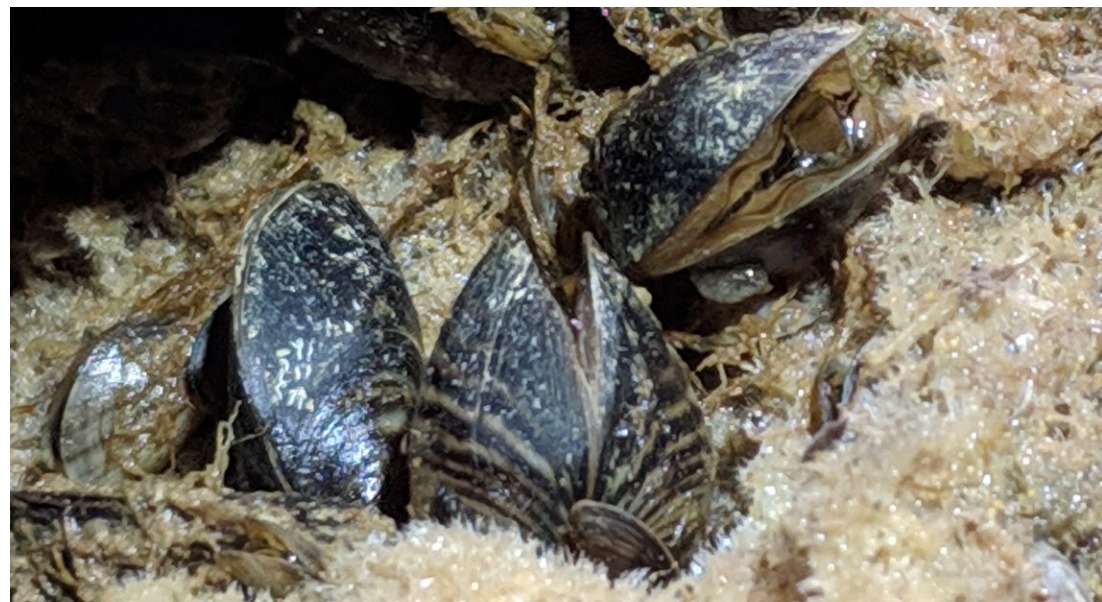
Turnouts continue to be infested with quagga mussels and other organisms (colonial hydroid, freshwater sponge, Asian clams, etc.). These organisms effect the flowmeters located within the barrels of the turnouts, so they need to be periodically dewatered and cleaned.

Quagga mussels, freshwater sponge, and colonial hydroid found in GLETO in 2019. All three are considered invasive species and they create issues in turnouts by fouling flow meters and impacting flows.

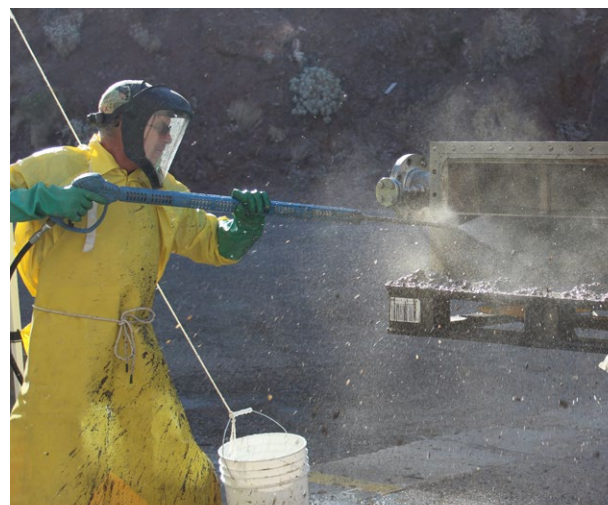
Quagga mussels continue to persist throughout the CAP system, but problems associated with the invasive species are relatively minimal. The exception is the cooling water system at MWP, where quagga and colonial hydroid settlement have caused increased cooling water temperatures at each of the motor units. This causes the motors to overheat and trip, requiring disassembly, power washing of the coolers, reassembling, and a restart. A chemical injection system has been designed and will be installed in 2020 to help prevent future settlement of invasives in this critical system.

Infestations in the cooling water system at MWP requires periodic power washing to ensure that motors do not overheat.

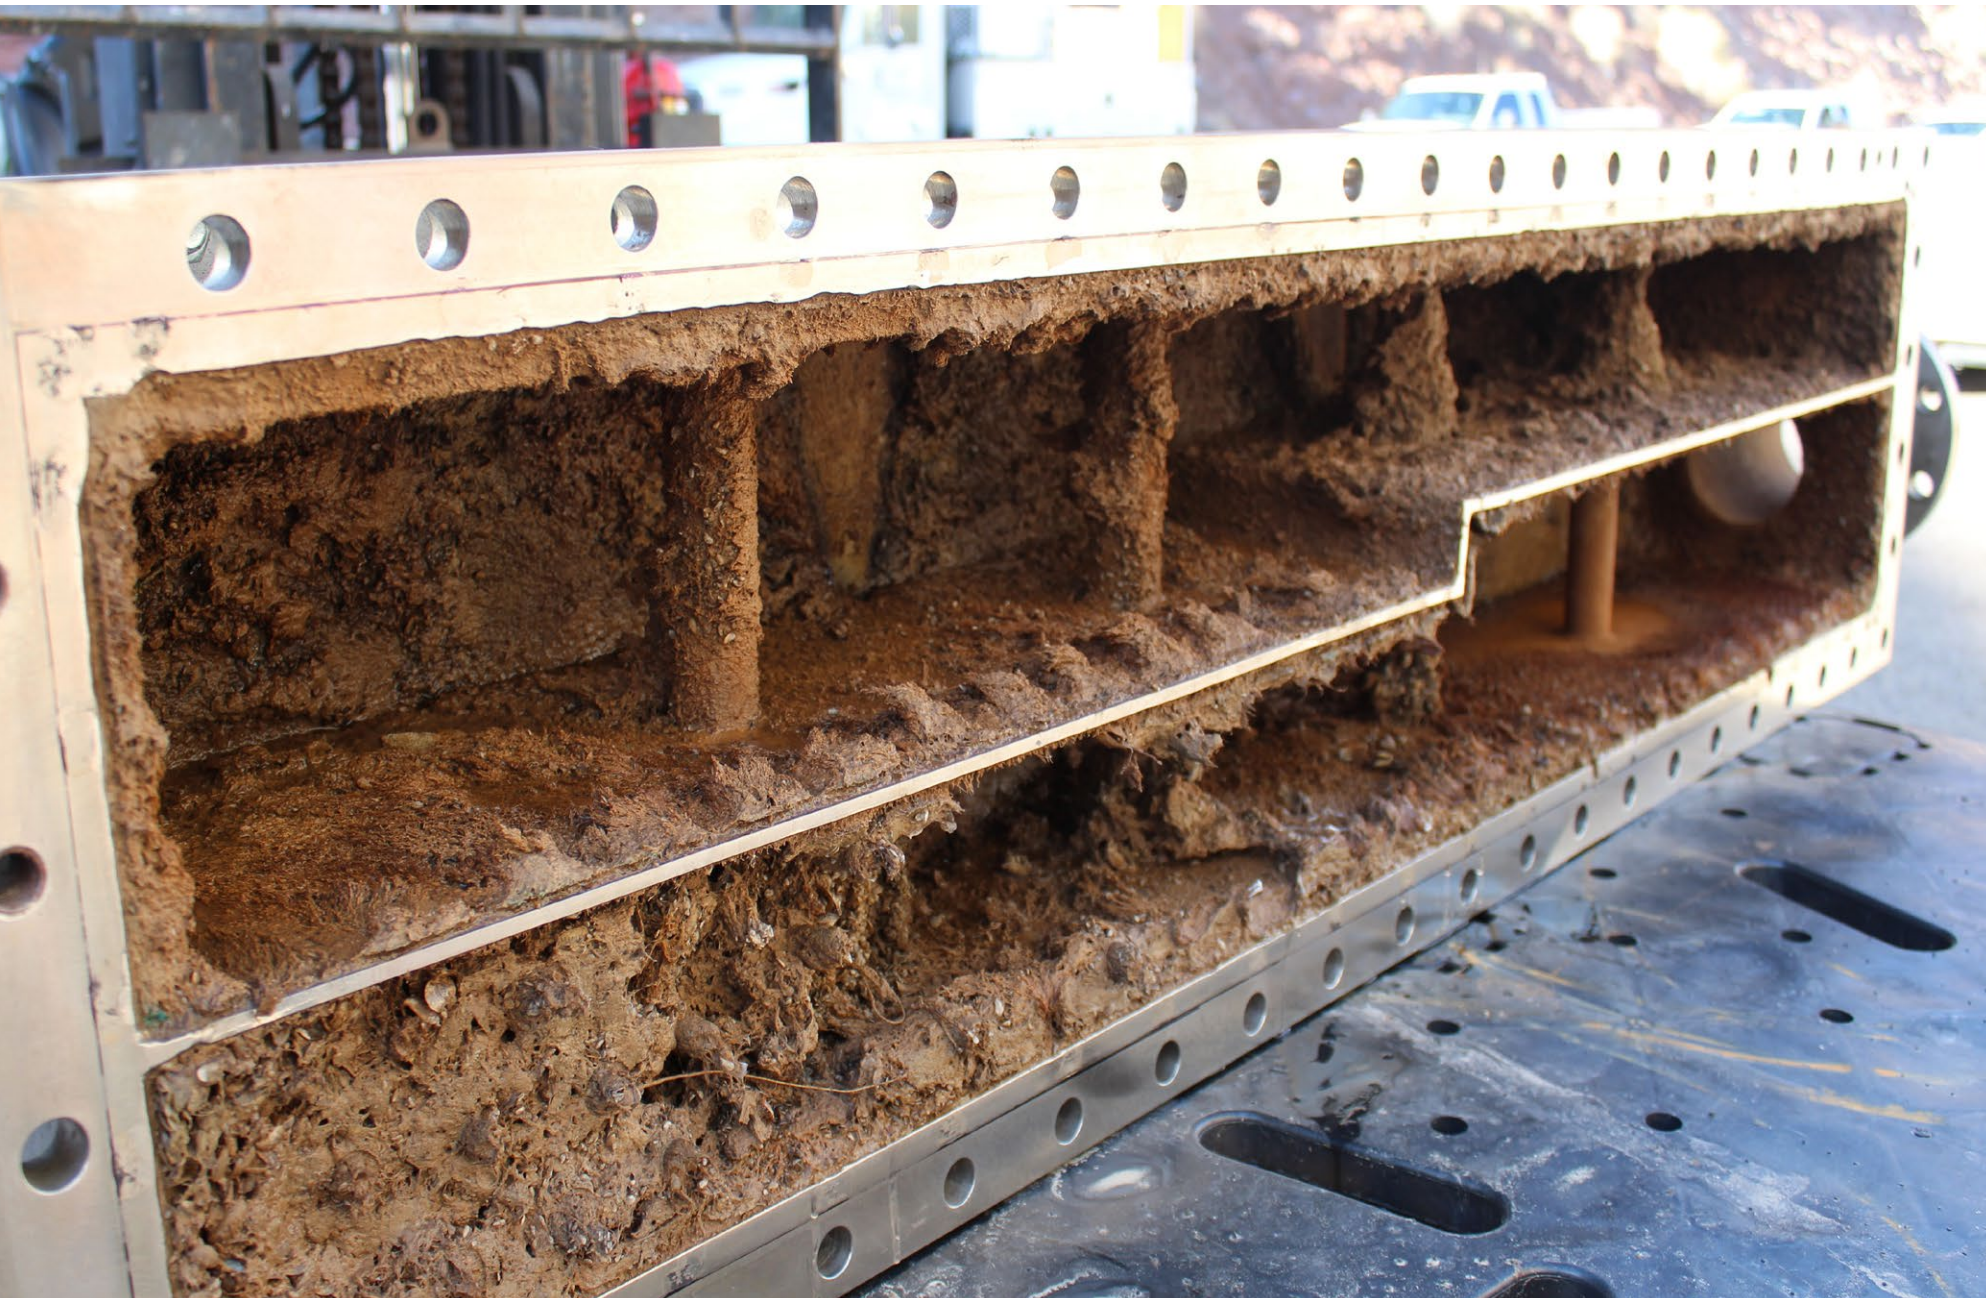
QUAGGA MUSSELS, COLONIAL HYDROIDS AND SEDIMENT IN COOLING UNITS AT MWP
Photo by Scott Bryan

In 2020, all cooling units at MWP will be treated with copper sulfate to prevent quagga attachment.

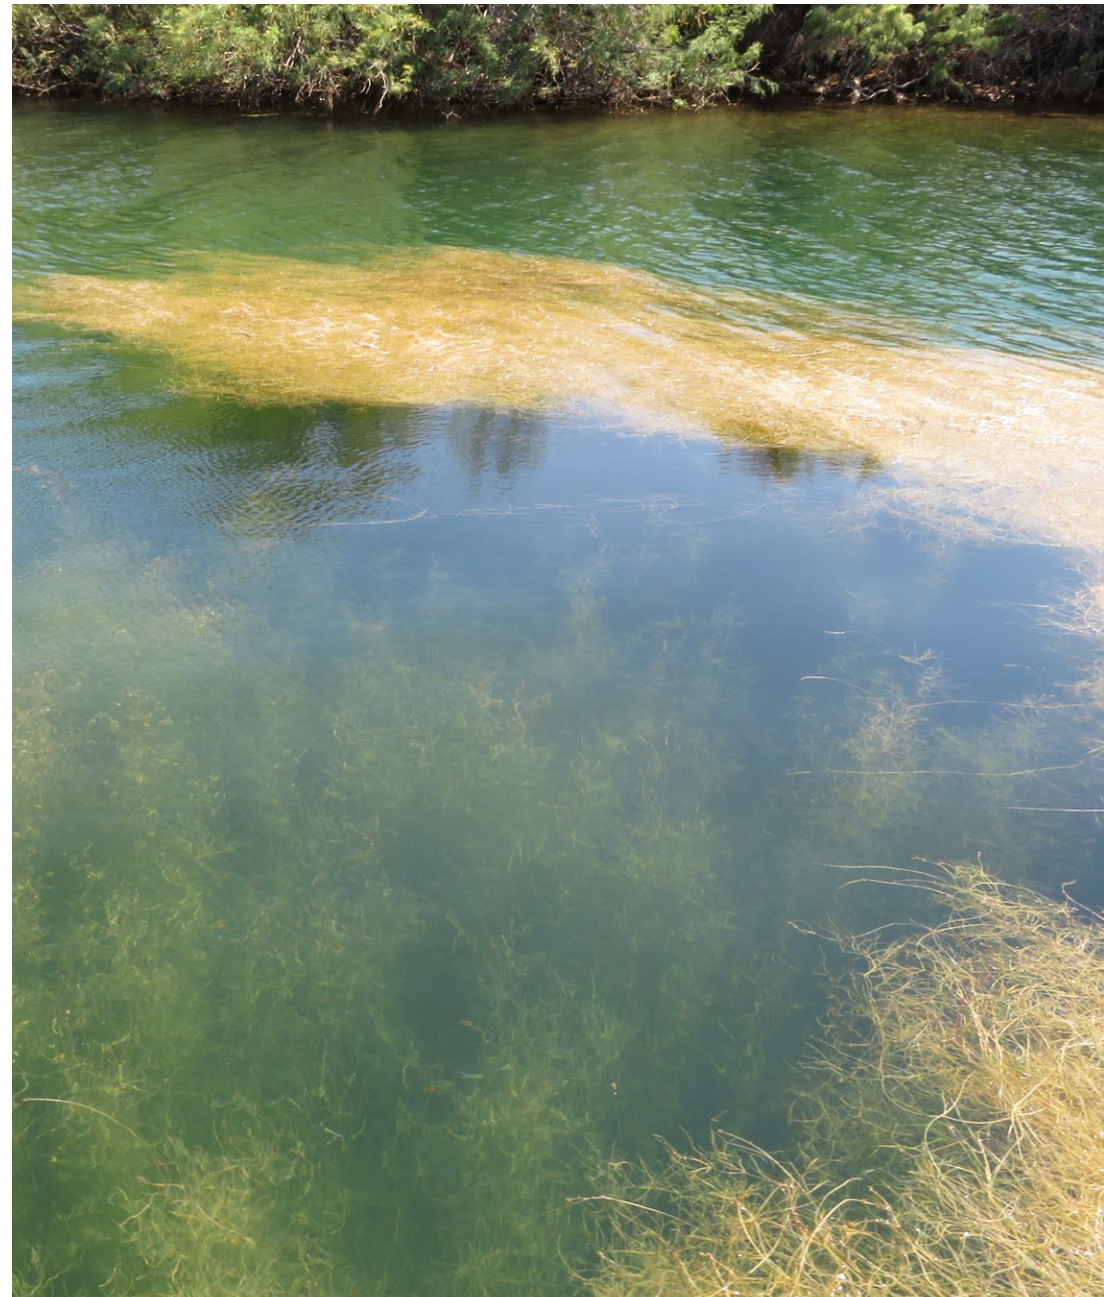
VEGETATION GROWTH IN MWP INTAKE CHANNEL

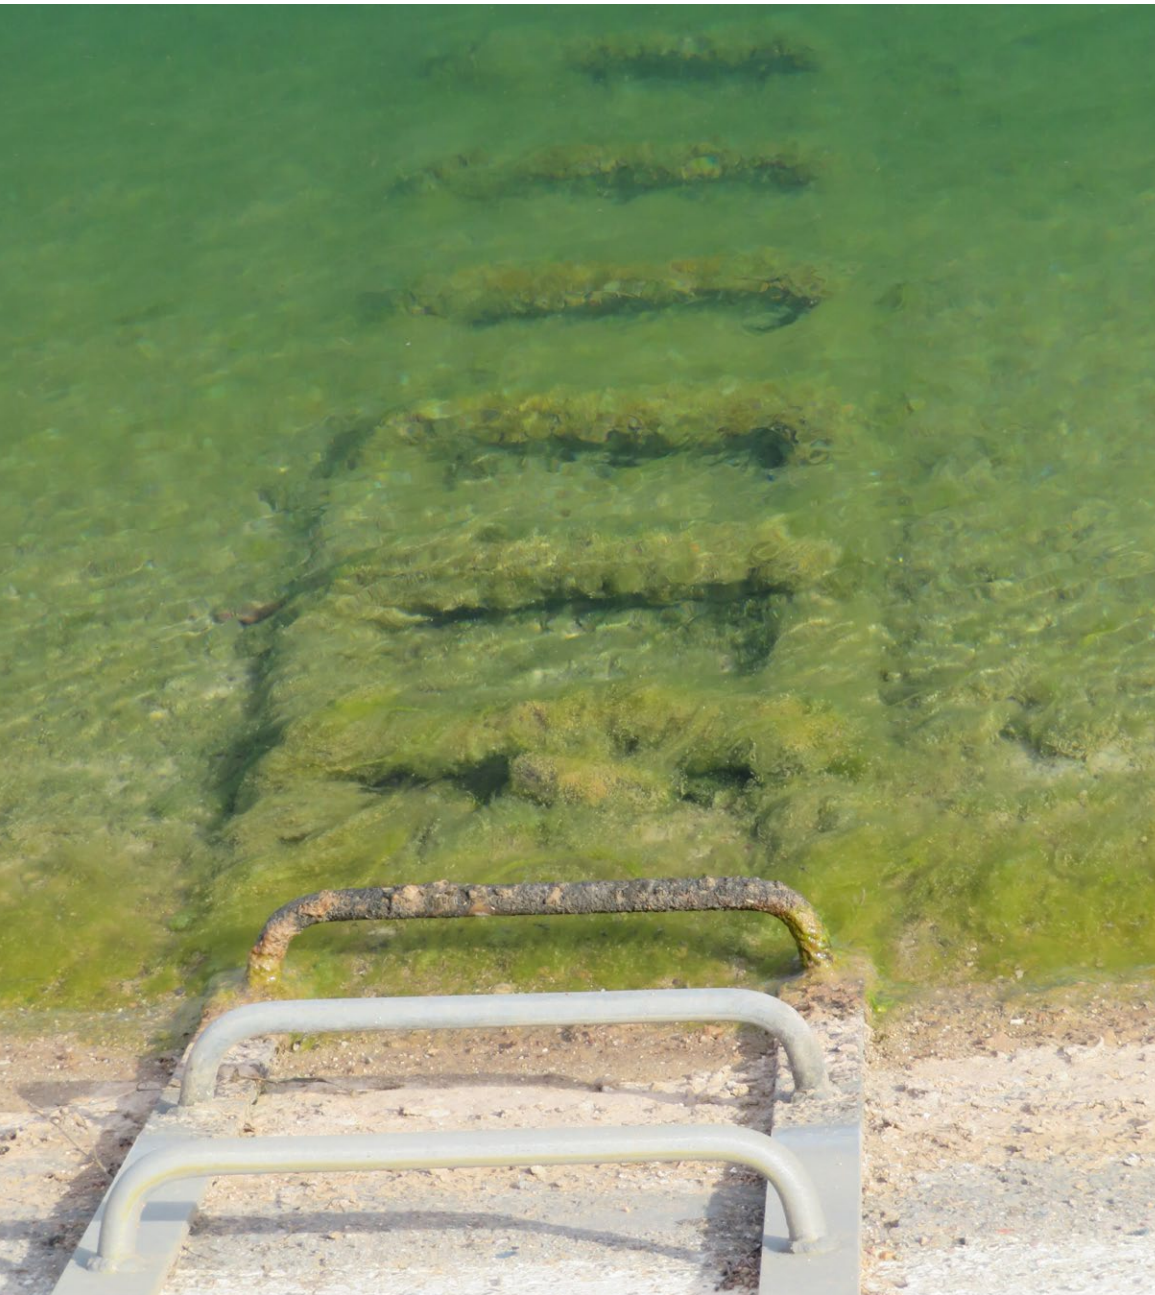
ALGAE GROWTH IN POOL 15 IN APRIL 2019
Photo by Scott Bryan

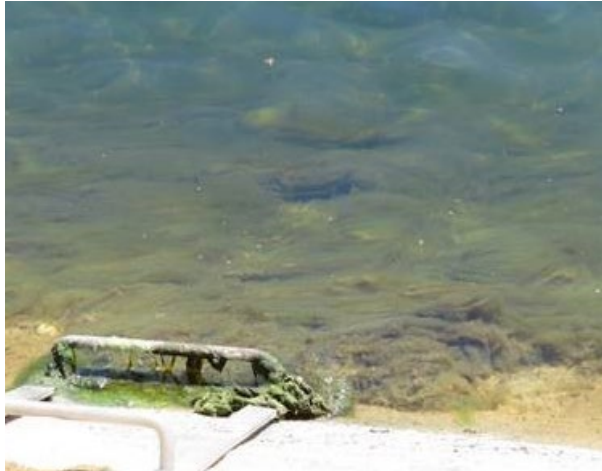
Filamentous algae growth in WAD Canal in August 2019.

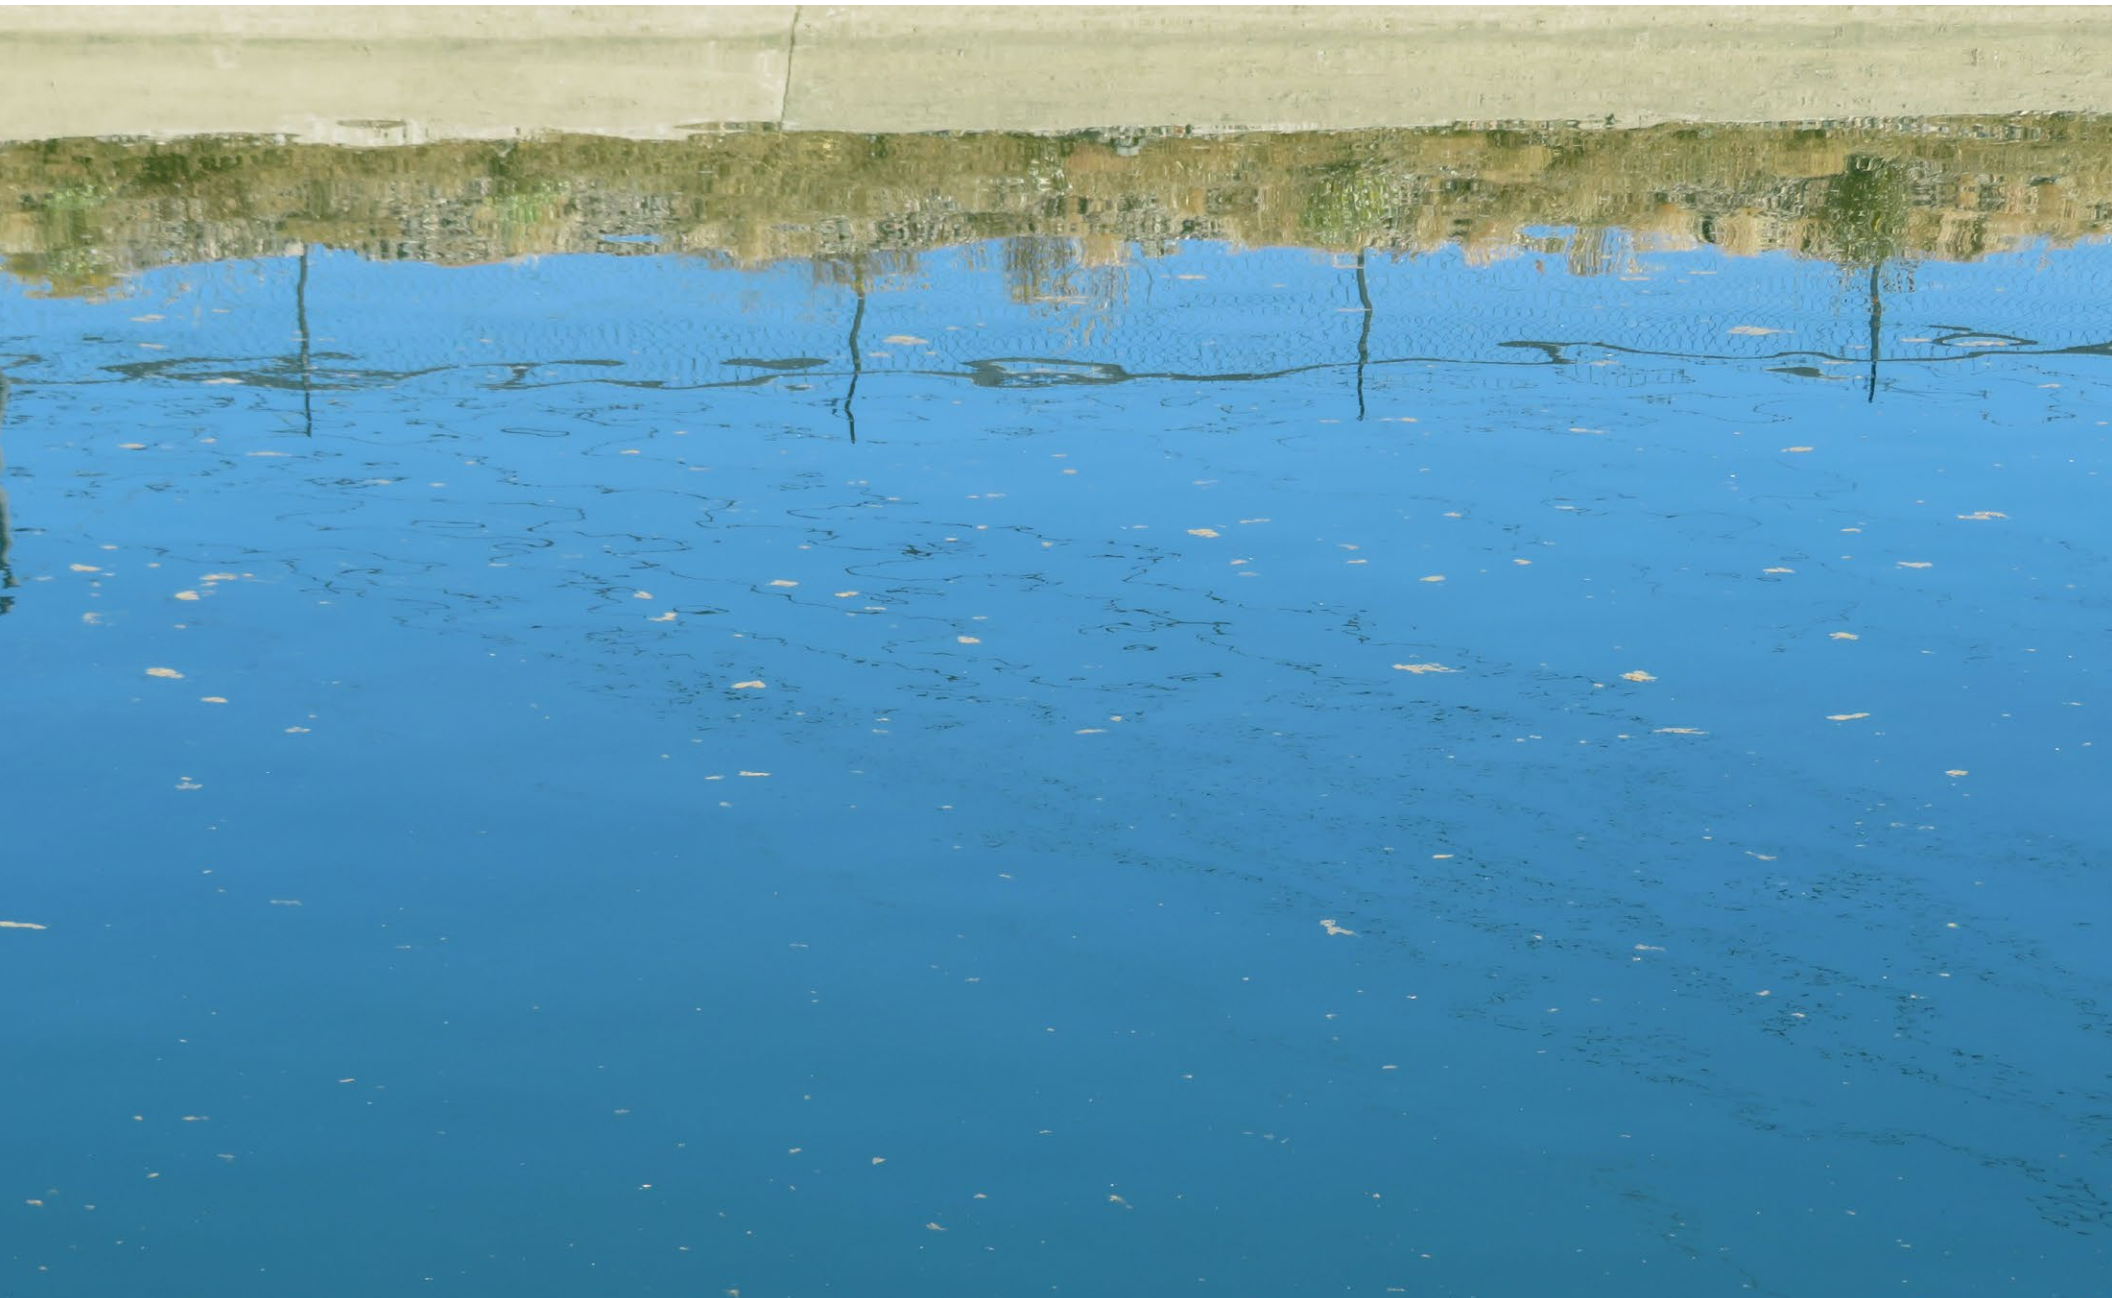
FLOATING ALGAL DEBRIS IN WAD CANAL IN APRIL 2019
Photo by Scott Bryan

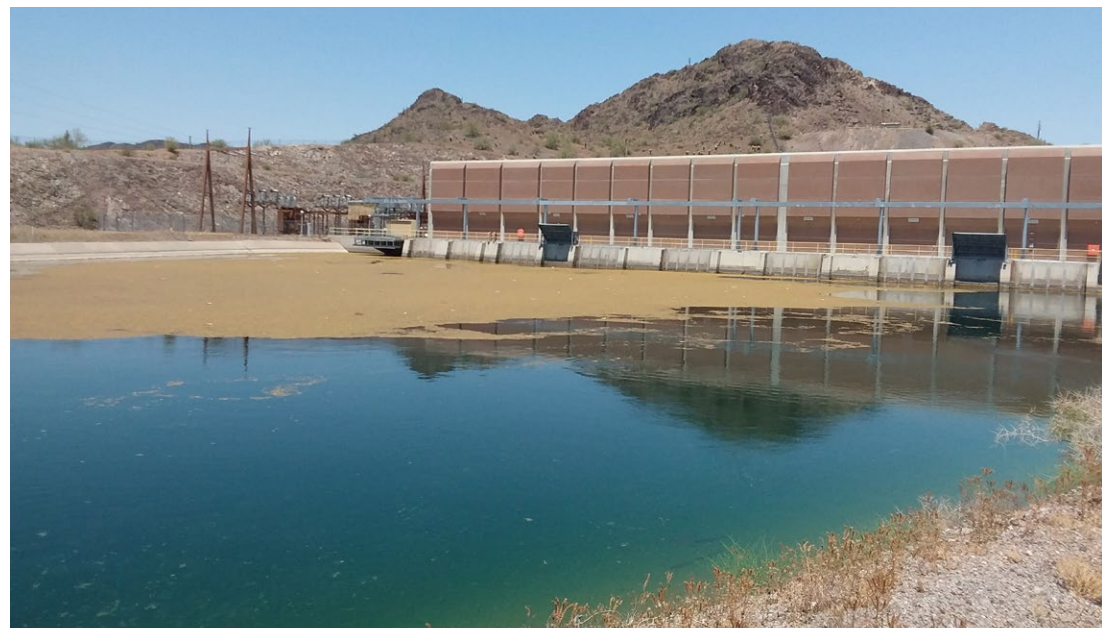
When *Cymbella* detaches from the canal liner, it forms dense mats that accumulate and can impact water flow, as well as clog filters, strainers and other critical infrastructure.

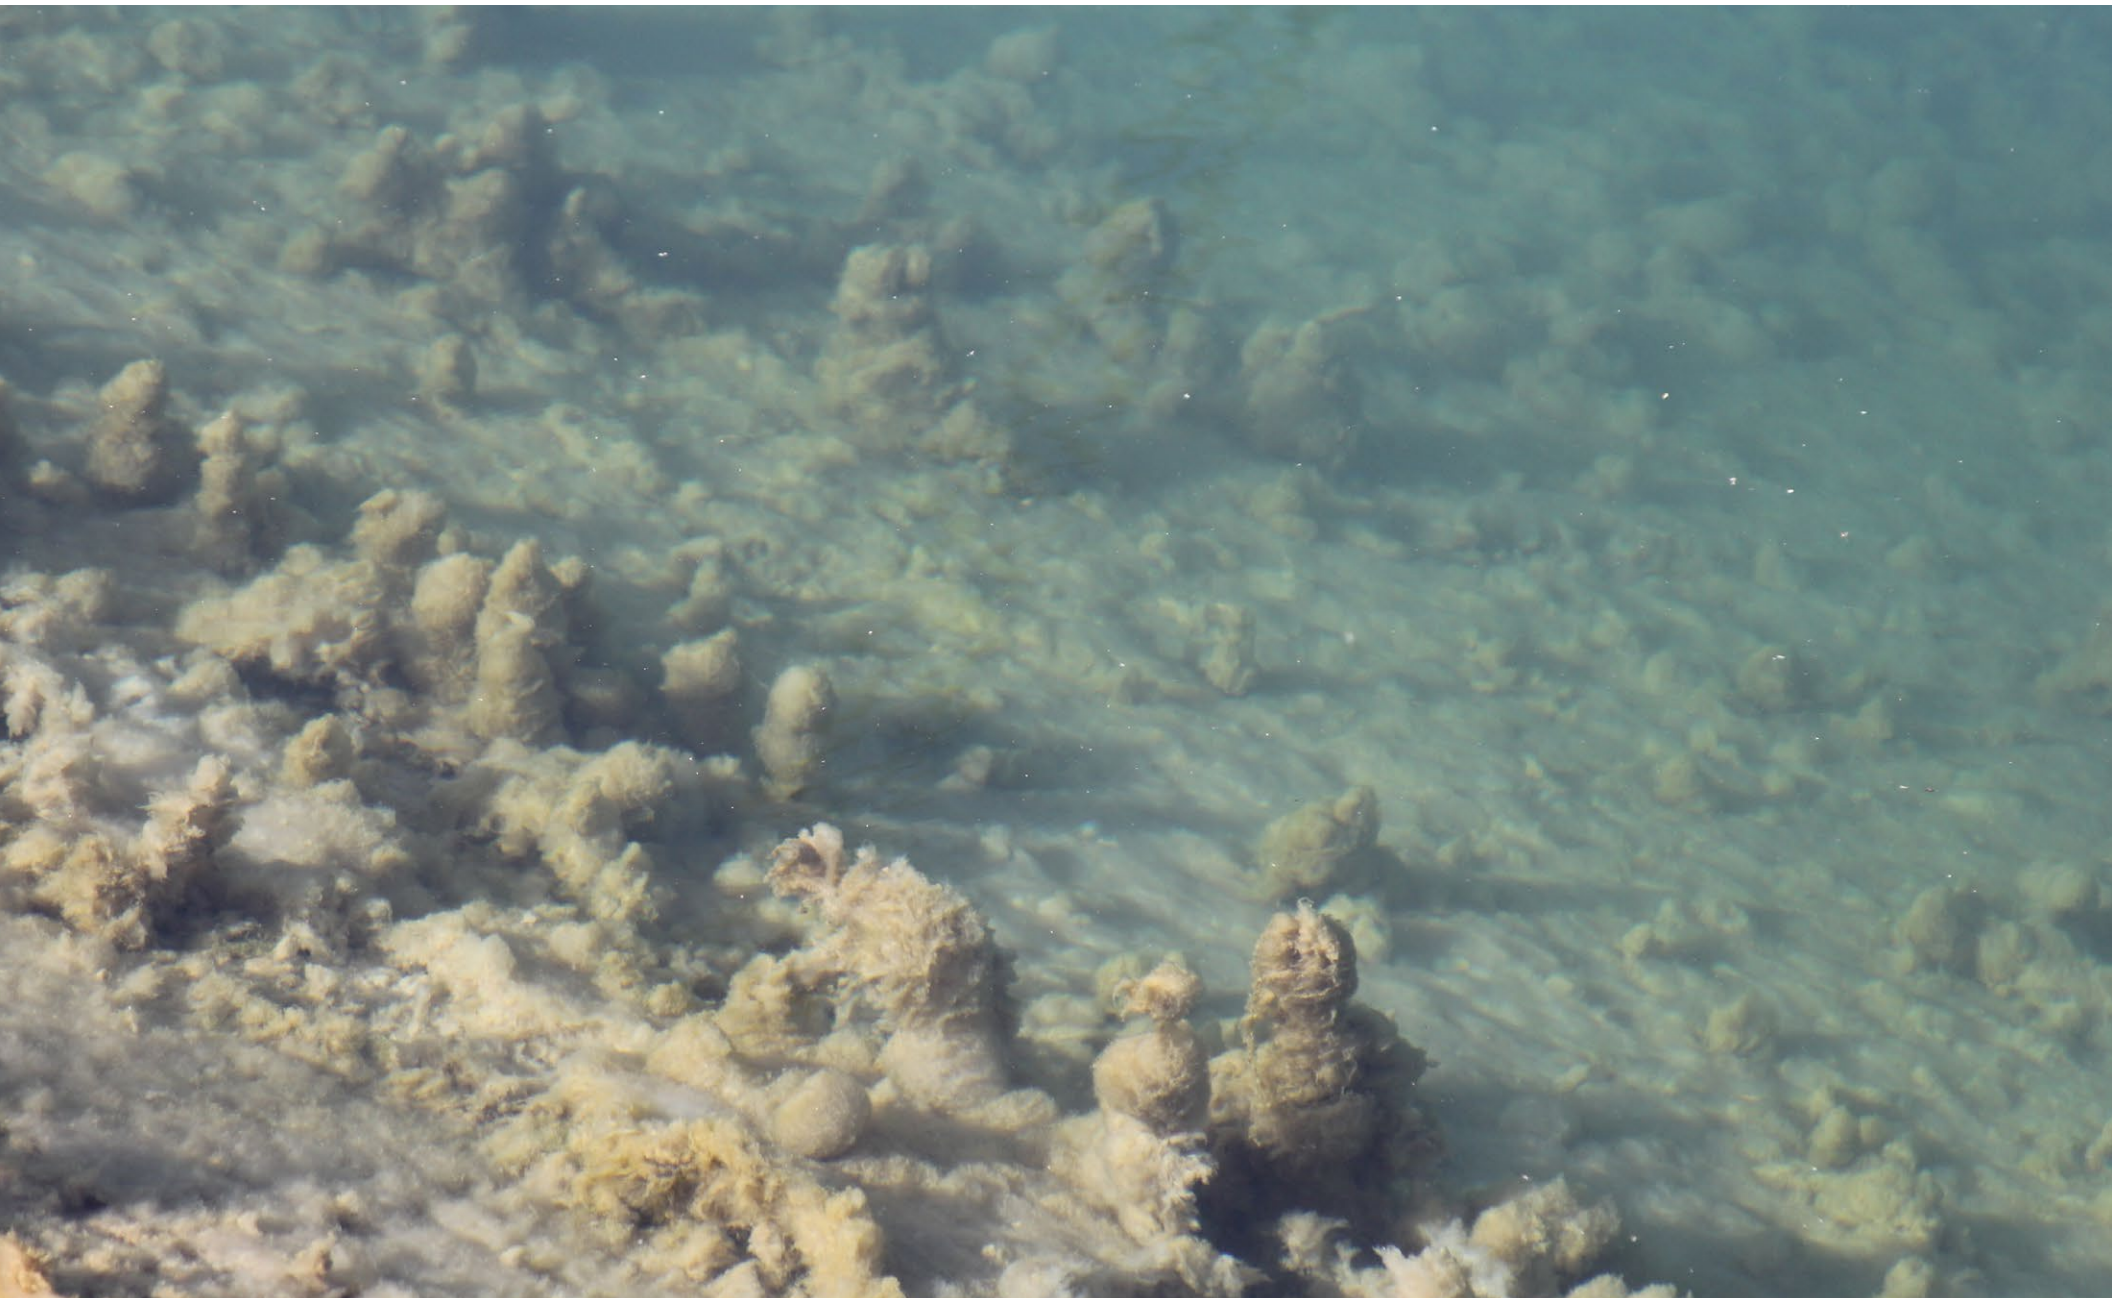
CYMBELLA CAN GROW ON THE CANAL LINER AND CREATE ISSUES FOR CAP AND ITS CUSTOMERS
Photo by Scott Bryan

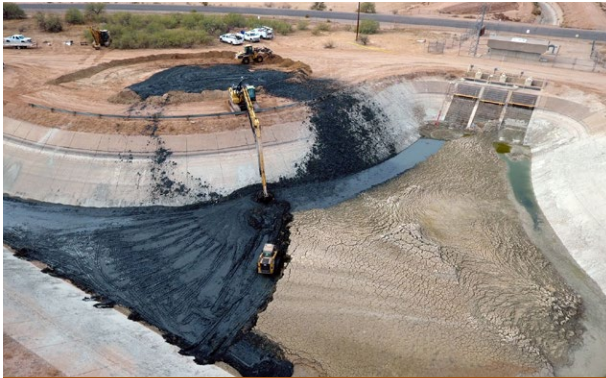
Sediment at SMATO in November 2019.

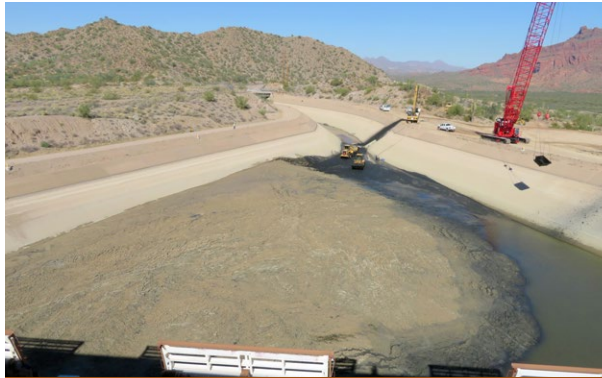
Sediment in SGL Forebay in November 2019.

Sediment mapping in April shows that sediment volumes continued to vary greatly among pumping plants. As in previous years, SGL, BRD, and PIC have sediment volumes that are over 30% of the forebay capacity, and SAN is over 28%. BRW and SXV continued to have the lowest sediment volumes in 2019.

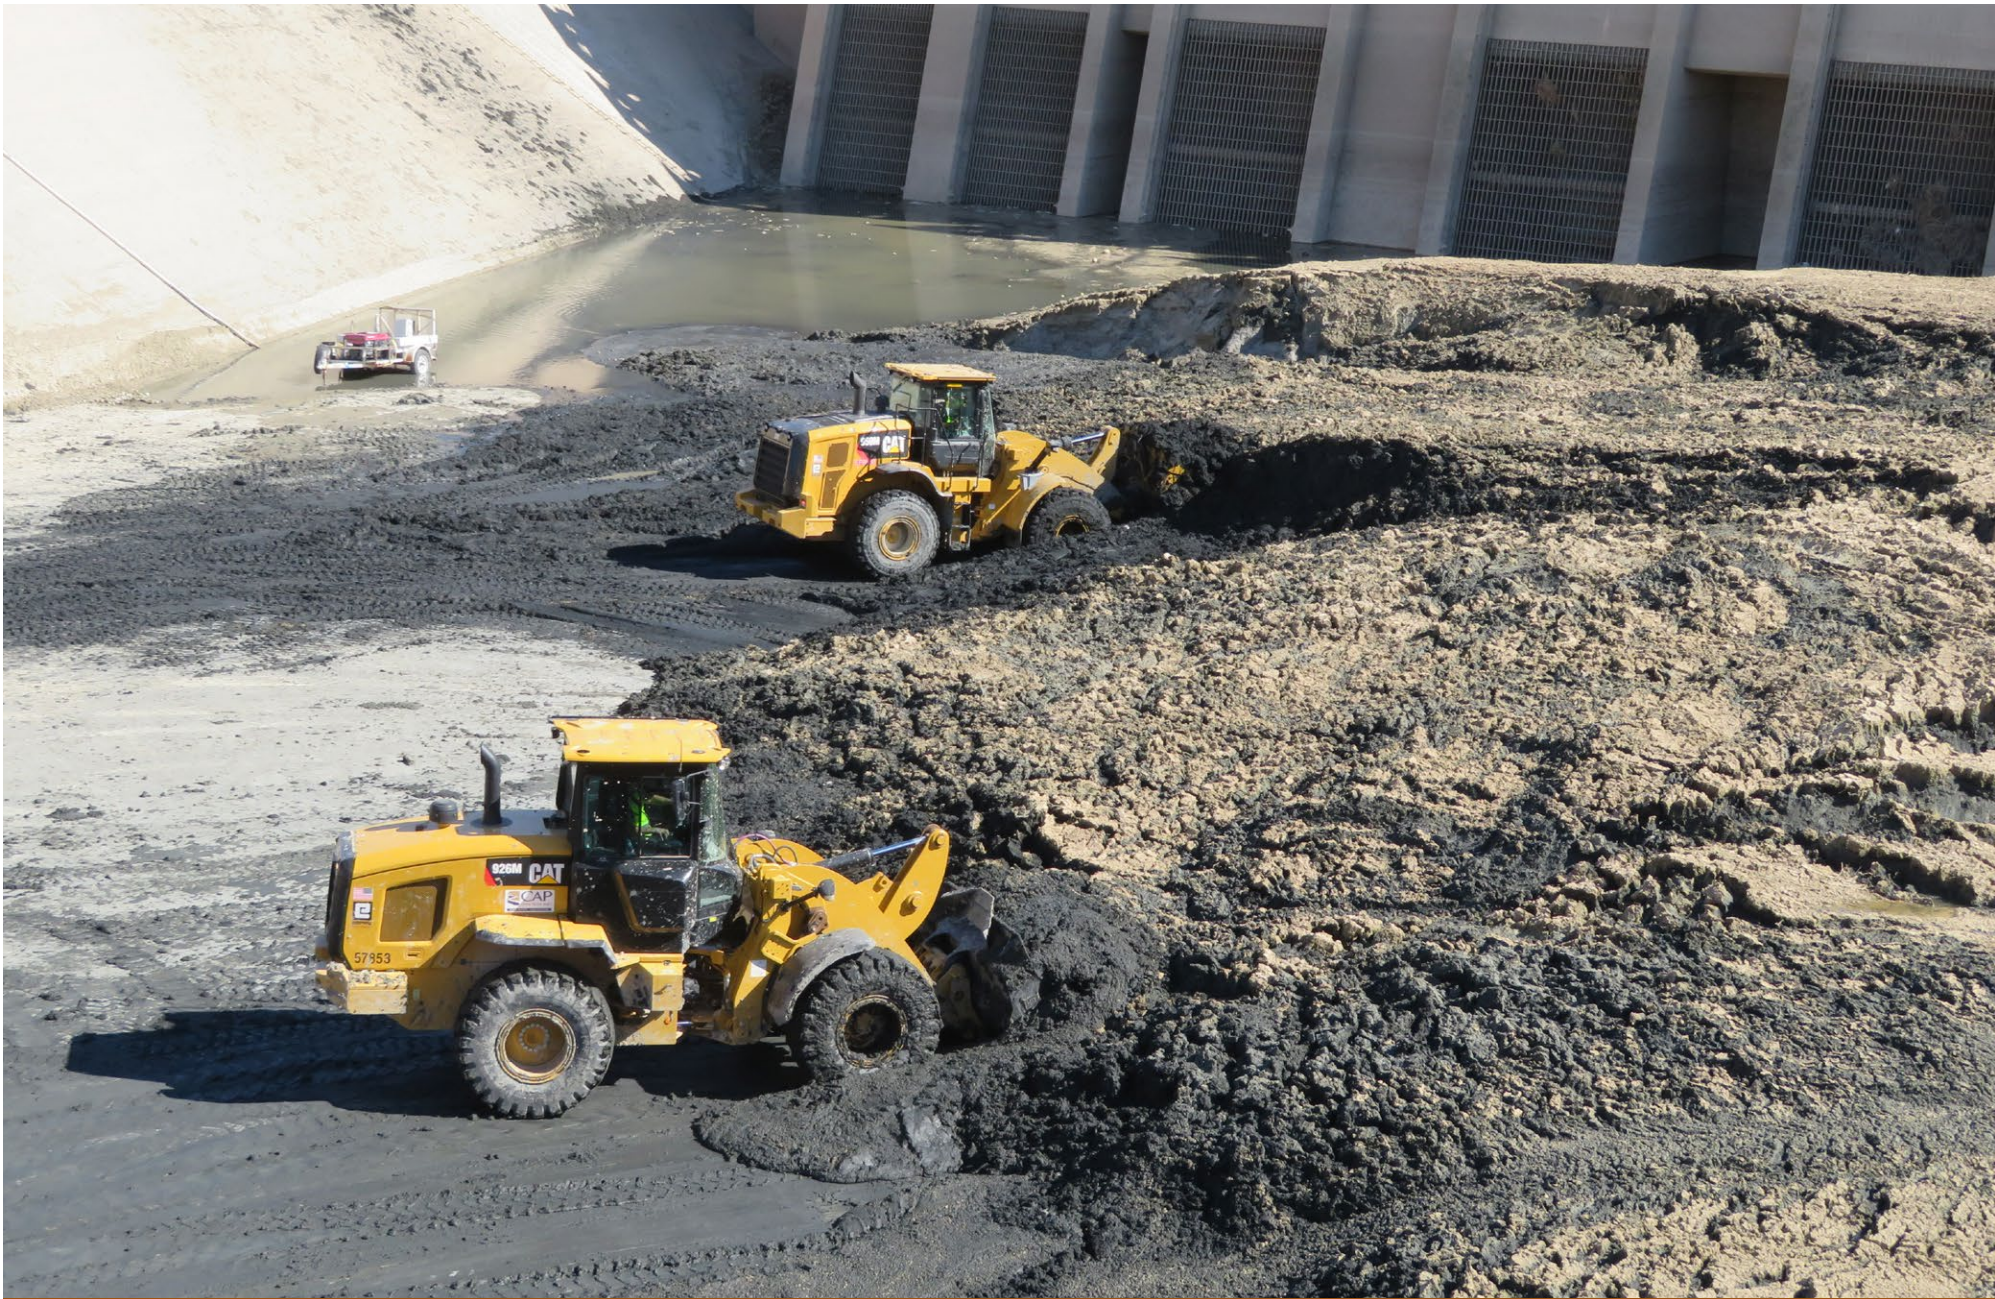
At SGL, CAP crews removed an estimated volume of 24,700 cubic yards of material (as determined through mapping) in just over 12 days. However, at large turnouts, the reach of the excavator/clamshell restricted the amount of sediment that could be removed (only 10-52% removed). Mapping following these removal efforts at turnouts indicates that sediment deposition was back to pre-removal levels within 9 months.

HEAVY EQUIPMENT IS USED TO HELP TO REMOVE SEDIMENT IN SGL FOREBAY DURING THE 2019 FALL OUTAGE
Photo by Scott Bryan
