2019
BIOLOGY
ANNUAL REPORT

Central Arizona Water Conservation District
Water Transmission
by Scott Bryan, Senior Biologist

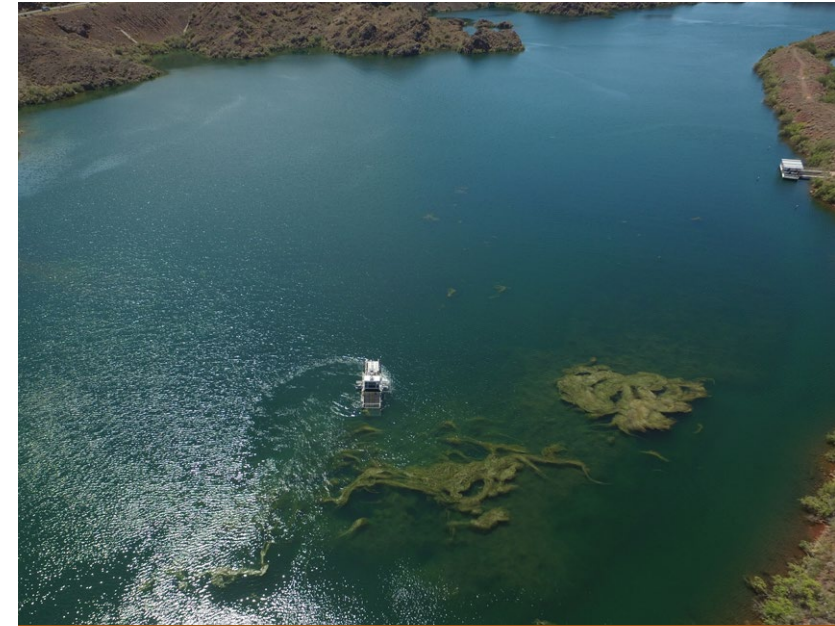
Floating weed mats are collected by a weed harvesting boat to ensure that the mats do not impact the MWP pumping plant.

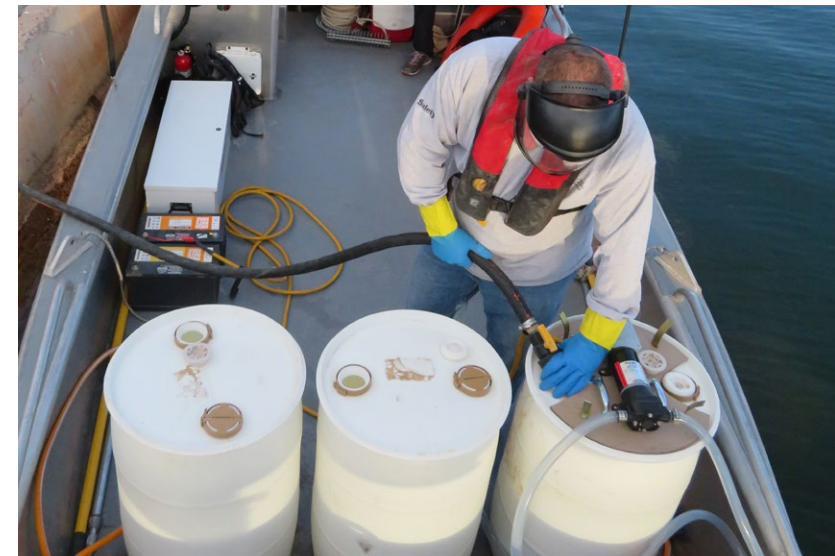
The pilot weed treatment was determined to successfully control the vegetation that was present at the time of application; nearly 99% of the vegetation (pondweed spp.) was eliminated within three weeks of the treatment. However, five weeks after treatment, vegetation began to grow within the study area. This new growth was determined to be a different species (naiad spp.) which was not present at the time of the initial treatment. The full report of findings and recommendations is available upon request.

A pilot weed treatment in May resulted in nearly 100% elimination of weeds in a 5-acre test plot.

In 2020, CAP will expand the Cascade® treatment to the entire 65-acre intake channel with two treatments: one in May to control pondweed species, and one in July to control naiad species. Vegetation coverage and plant height will be mapped bi-weekly to evaluate the effectiveness of the treatments and monitor overall vegetation growth. CAP weed collection crews will continue to harvest weed mats as necessary. CAP’s weather station will be downloaded monthly to correlate weather/wind events with the movement of vegetation mats.

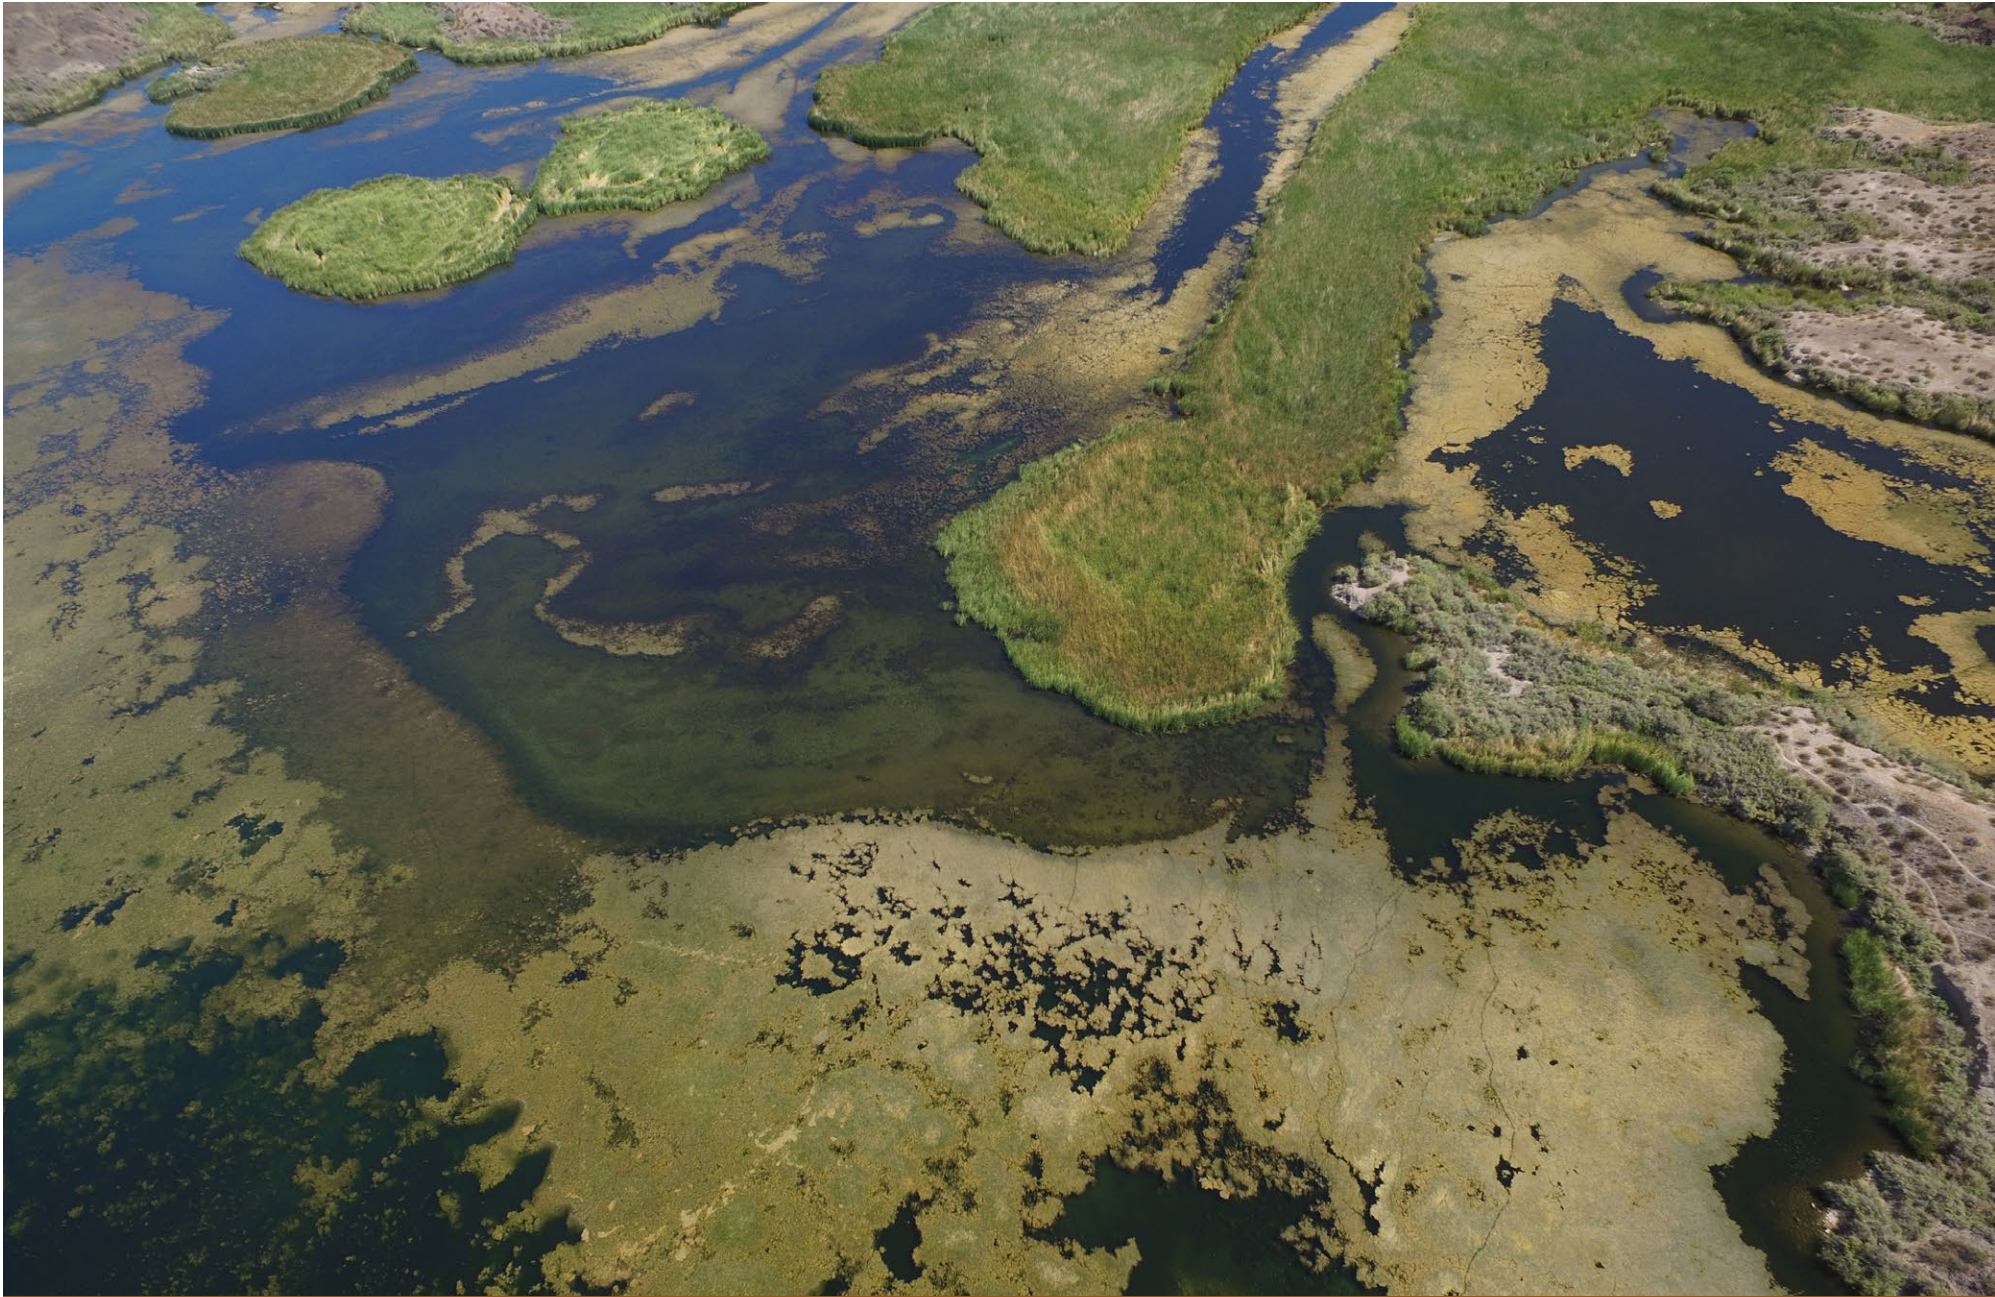
Aquatic vegetation growth in Lake Havasu has increased significantly since the discovery of quagga mussels in 2008. The direct relationship between quagga mussels and vegetation growth has not been proven; however, it is widely speculated that quagga have increased water clarity and nutrient loading in the reservoir, which in turn has led to an increase in weed growth. When the vegetation dies and floats to the surface during summer and early fall, the impacts are felt by CAP. Weeds become entrained in the flow of the intake channel, either as individual plants that have been dislodged or as floating mats of dead material, and threaten the reliability of the pump systems.

AQUATIC VEGETATION GROWTH IN THE LOWER PORTION OF LAKE HAVASU IN 2019
Photo by Michael Rogers

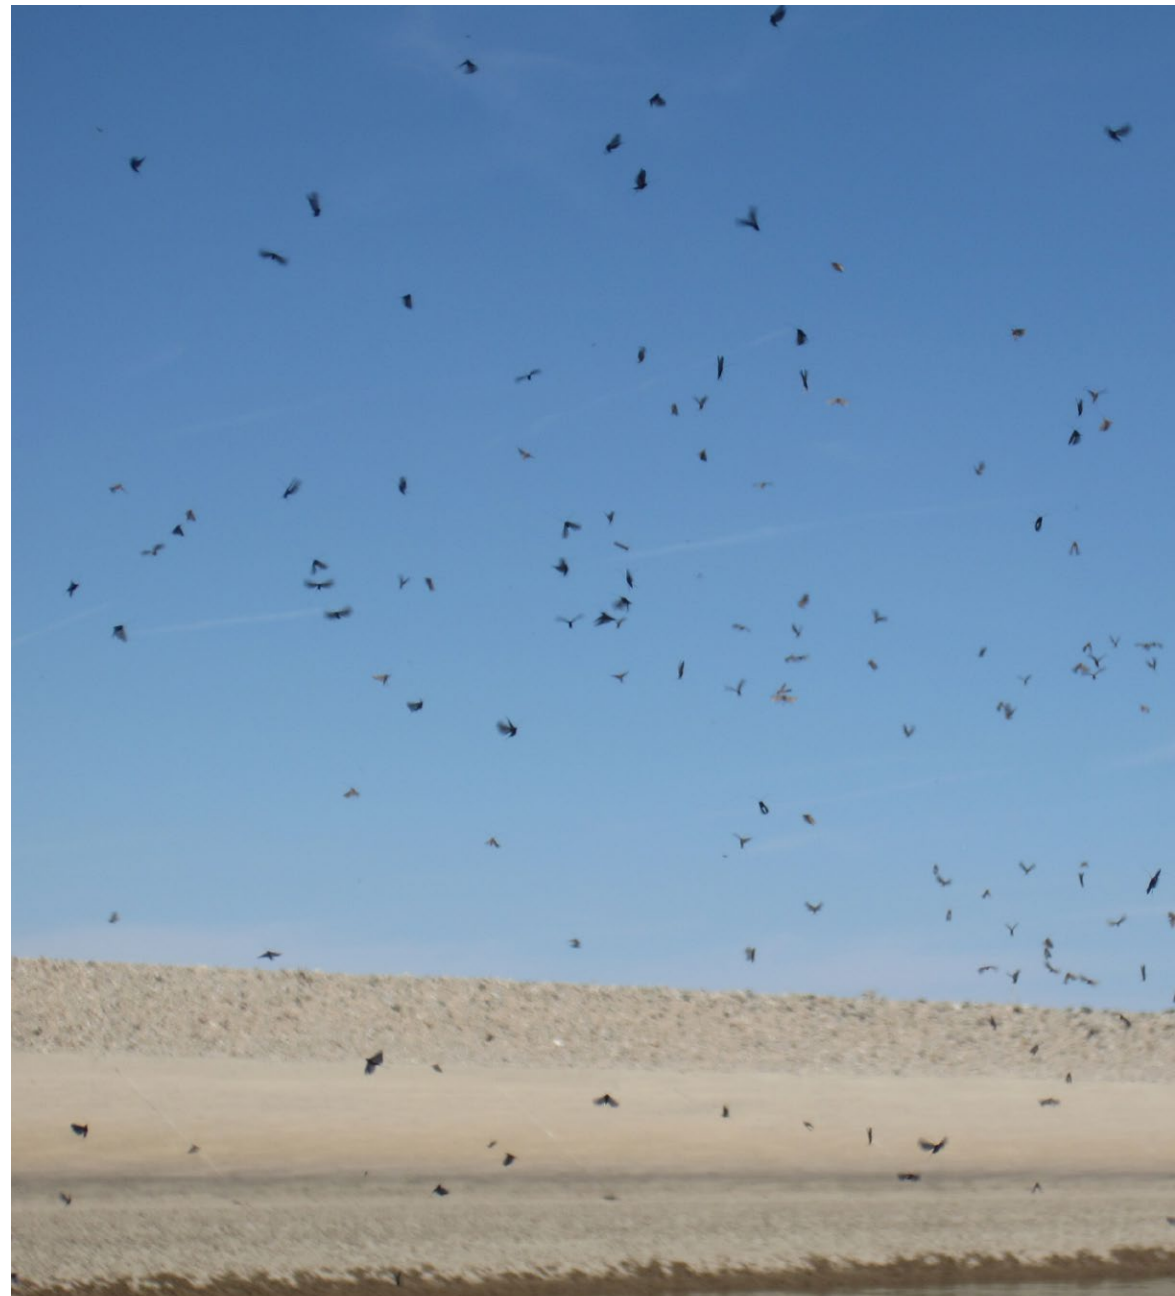
In 2004, a nuisance insect was reported to CAP by Phoenix and Scottsdale residents. The insects were identified as *Smicridea*, a common genus of caddisfly that is indigenous to the Colorado River. Although 2004 was the first record of complaint by nearby residents, caddisflies were found in relatively high numbers in the CAP as early as 1993. It is likely that caddisfly swarms have been common since the canal was constructed, but were largely undetected because people did not live near the canal. The emergence of large numbers of adult caddisflies causes a nuisance because they tend to swarm around people, making outdoor dining and entertaining uncomfortable during periods of high activity.

CADDISFLIES EMERGE FROM THE CAP IN POOL BOUSE
Photo by Scott Bryan

The catfish continue to provide a level of control, which appears to be improved with the stocking of smaller fish. CAP will continue to stock small catfish (~0.5 lb) in Pools 21-24, and will add Pool 20 as a stocking location. CAP Communications employees will notify the public about stocking events.

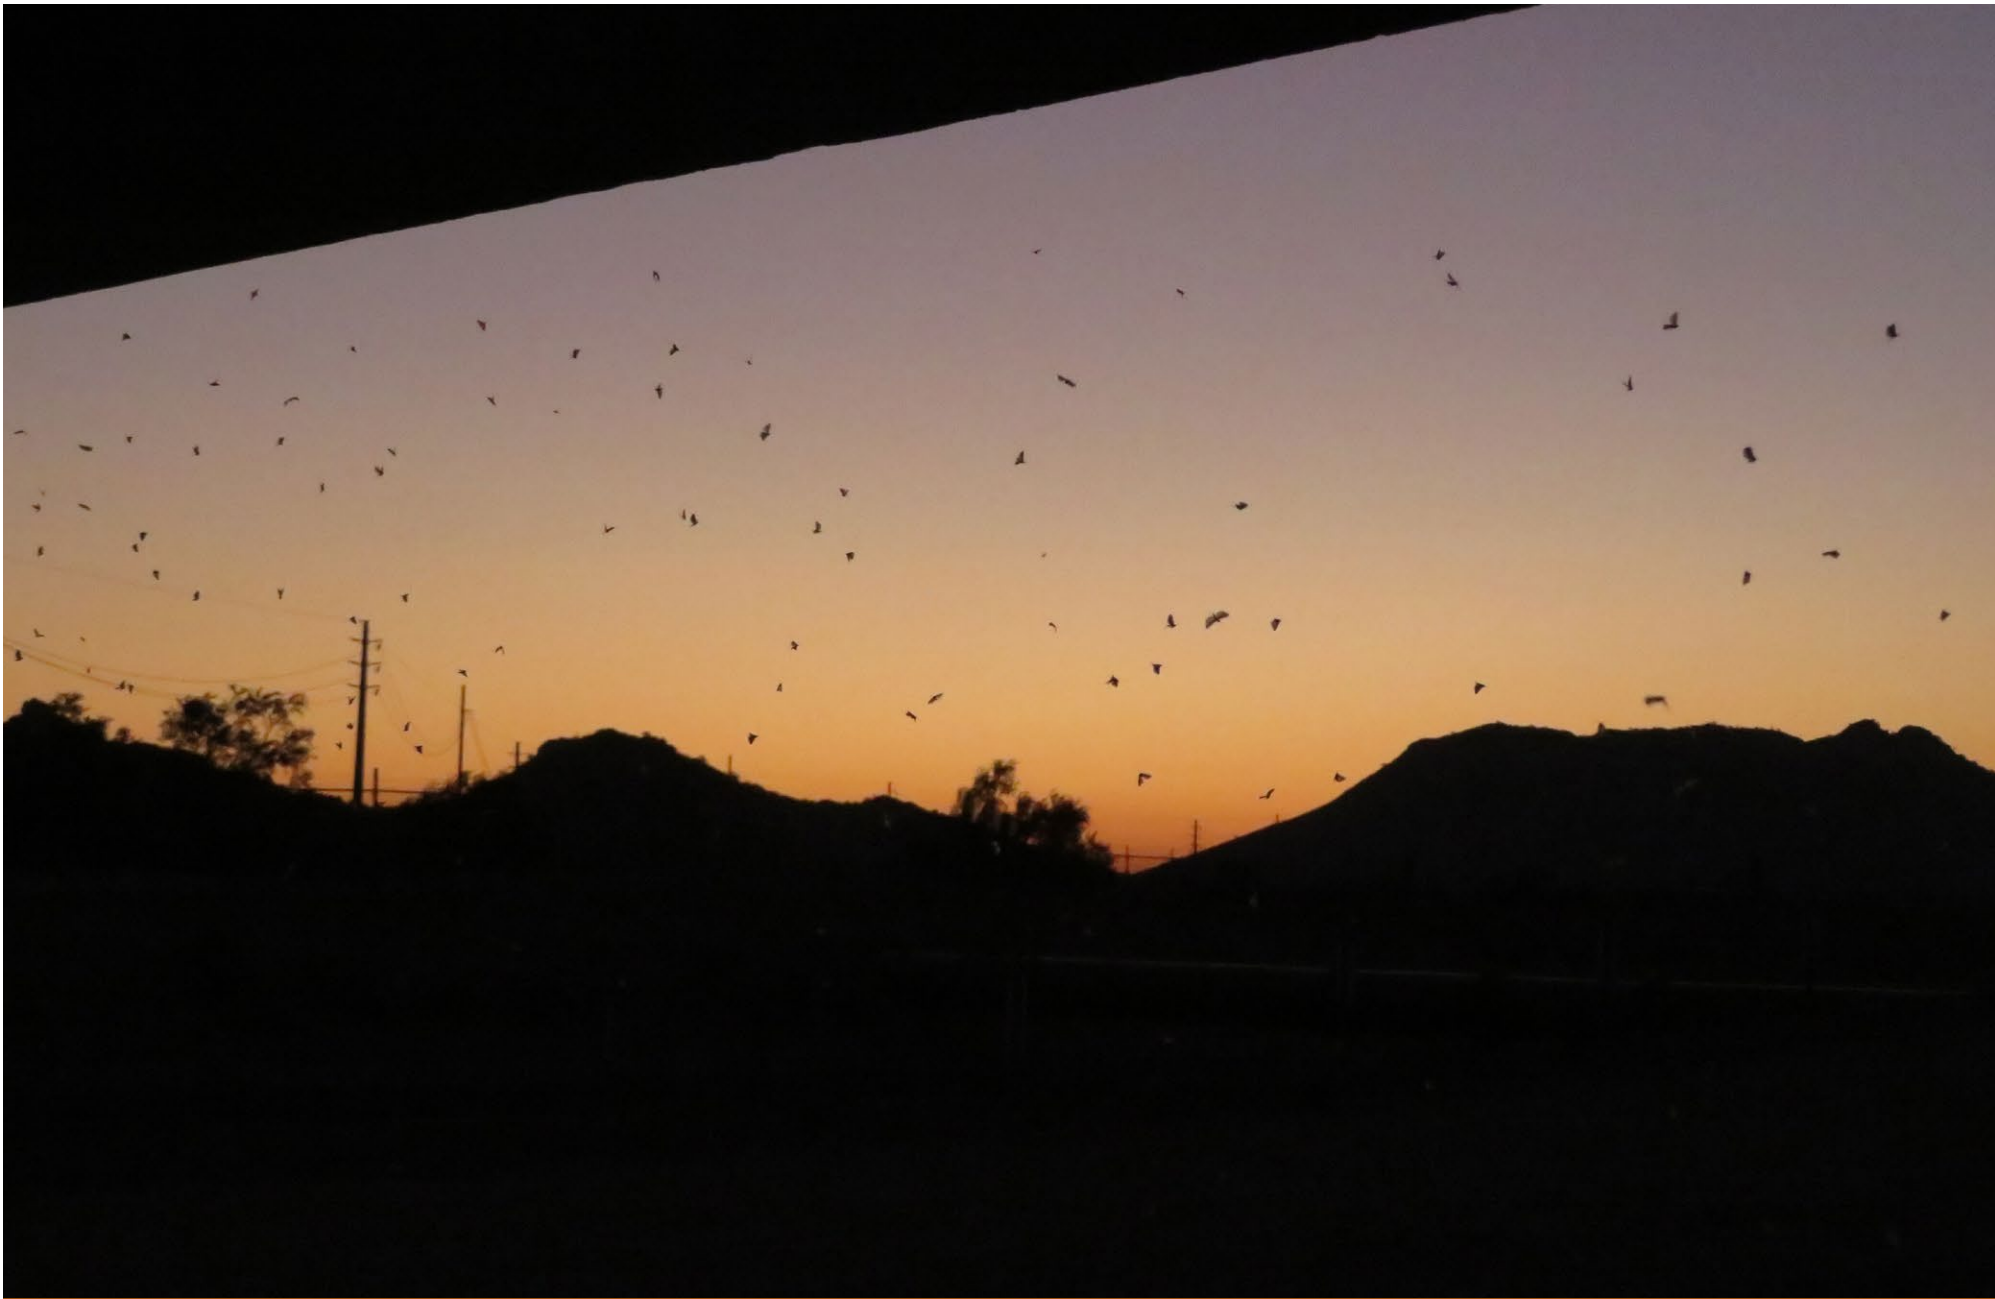
Based on the number of phone calls received from concerned neighbors, nuisance caddisflies were especially troublesome in 2019. There were 34 total phone calls, with over half (18) coming from residents adjacent to Pool 20. Calls from residents in Pools 21-24 came primarily in July and August, while calls in Pool 20 were primarily in September and October. These were the first reports from residents near Pool 20 since CAP began to record names and addresses of callers. One reason for the increase in calls in Pool 20 is that these are relatively new neighborhoods, so nuisance caddisflies were not noticed in the past. In addition, the filamentous algae bloom in Pool Waddell and Pool 19 during spring 2019, may have created an ideal situation to produce a large caddisfly population. Finally, catfish have never been stocked into Pool 20 because it has not been identified as a problem area, so there were no control mechanisms in place.

CADDISFLIES SWARM DURING EARLY MORNING HOURS IN POOL 19
Photo by Scott Bryan

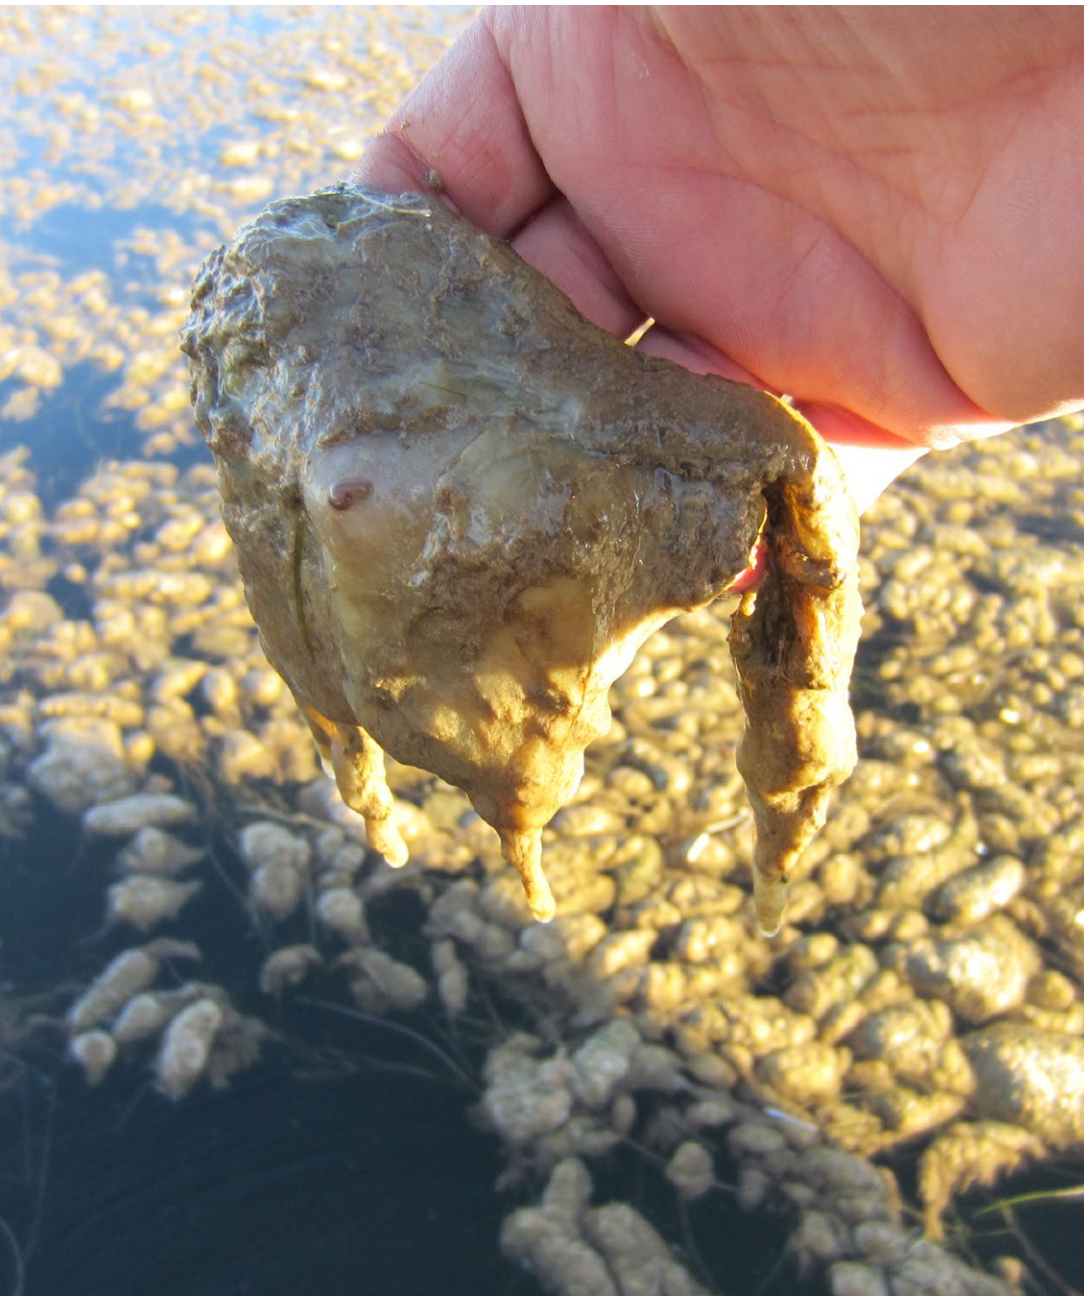
MATS OF CYMBELLA SPP. FORM IN LATE SUMMER IN THE CAP
Photo by Scott Bryan

Since the time of their discovery in the CAP (1997), stalk-forming diatoms have occasionally become a nuisance for both CAP and its customers. Cymbella can cause issues when it is attached to the concrete liner and when mats become detached and are floating on the water surface. When attached to the liner, the long stalks create excessive friction and reduce the flow of water. This impacts the ability of CAP Operations to deliver the requested volume of water to downstream water users. When floating on the surface, the mats of organic material may be drawn into pumping plants. Critical filters, strainers, and pumps have the potential to become clogged, which in turn affects the ability to properly cool motor components and provide service water throughout the plant. CAP customers can also be impacted, as clogged intakes, filters, strainers, and pumps reduce their ability to effectively deliver water to end users.

CAP will continue to monitor growth of *Cymbella* through periodic visual observations in areas where the nuisance diatom has been a problem in the past. CAP will also rely on customer reports of issues caused by floating mats of "rock snot" as it occurs.

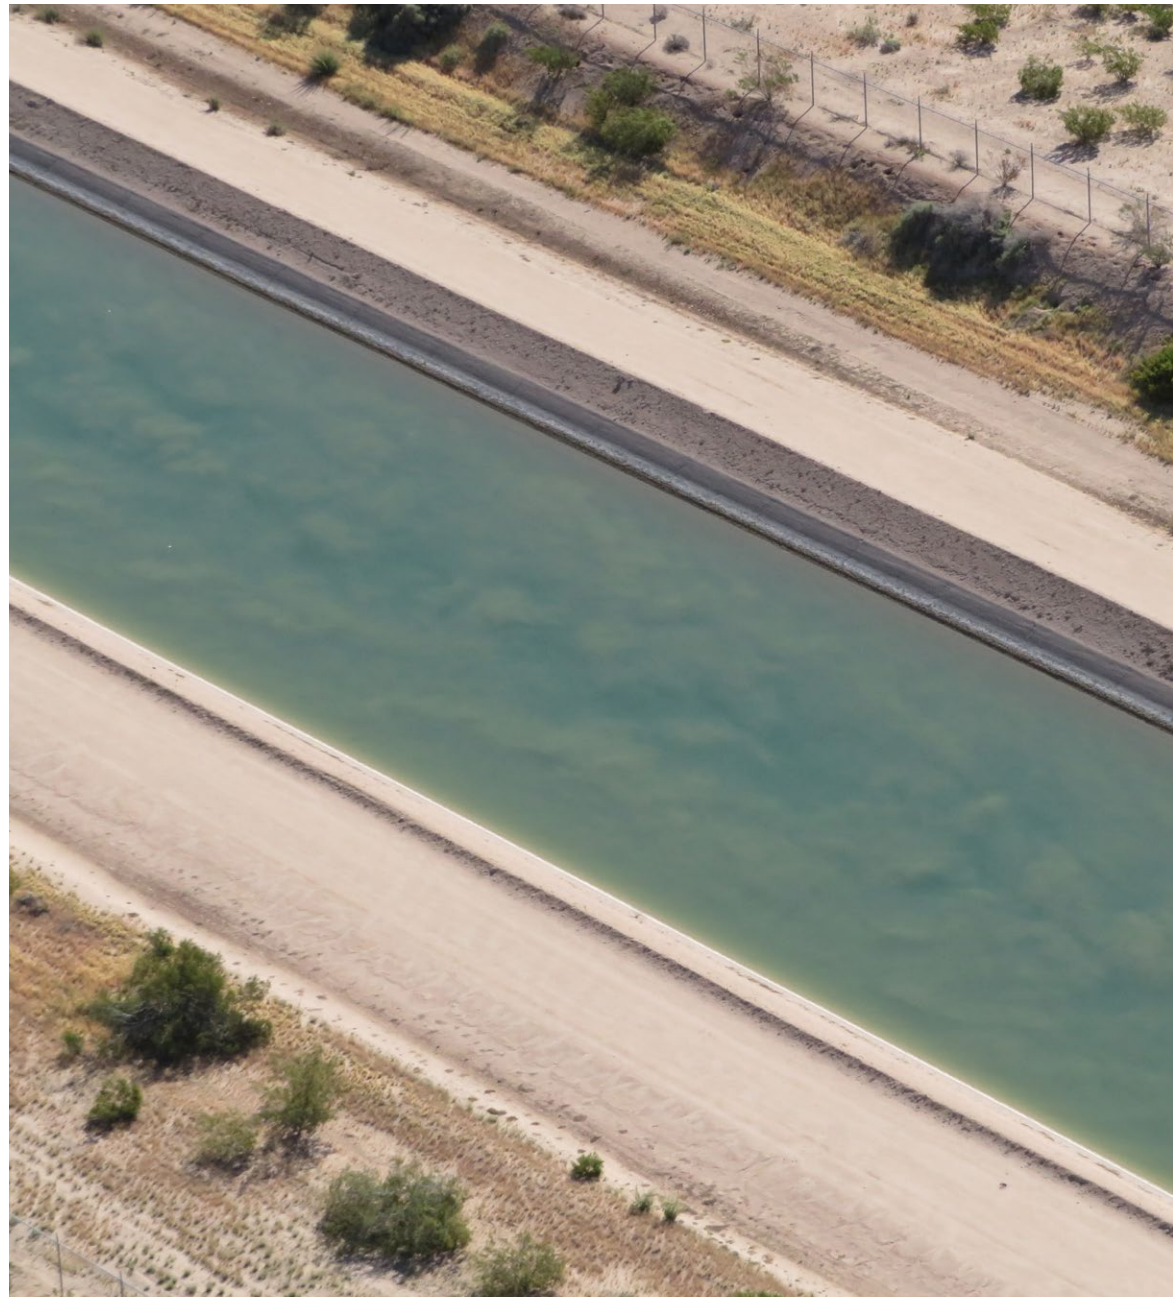
CAP Operations has indicated that water deliveries are rarely affected by sediment deposition. However, from a maintenance perspective, anecdotal evidence suggests that the sediment renders flow meters inoperable, clogs strainers and filters, causes premature wear to critical components (such as wear rings, impellers, and casings), degrades piping in cooling water systems, and causes wear and misalignment to trash rake systems. Nonetheless, increased maintenance and replacement of parts has not been quantified with data, so the impact of sediment deposition remains disputable.

SEDIMENT PLUMES MOVING THROUGH THE CANAL
Photo by Scott Bryan
